# Manhole Inspection Summary

Manhole # S13GG2020MH

**Location** Address: **5913 EASTCLIFF DR**

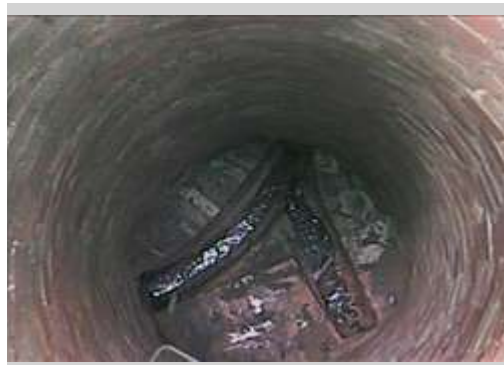
Top View

Infiltration: ☐ None ☒ **Joint** ☐ Cracks ☒ **Mortar** ☐ Roots ☐ Wall

**Bench** ☒ Exists Material: **Brick** ☐ Parged ☒ **Debris** (not Condition related)

Adjustment infiltration. Bench debris.

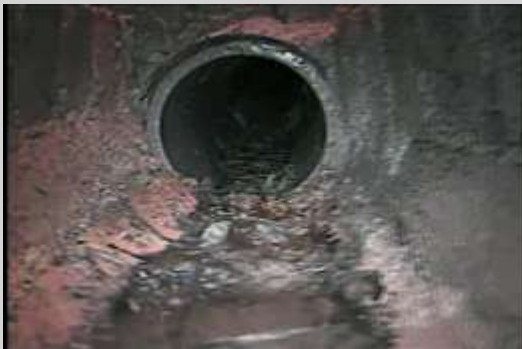
### 6 in. Circular Service Sewer Pipe In @ 5 O'Clock

Deposits: ☐ None ☐ Mud ☐ Sludge ☒ Debris ☒ Grease

Silt Depth: **1** (in.) Deposits Extent: **Light**

Infiltration: **Evidence** Pipe Seal Cond: **Unknown**

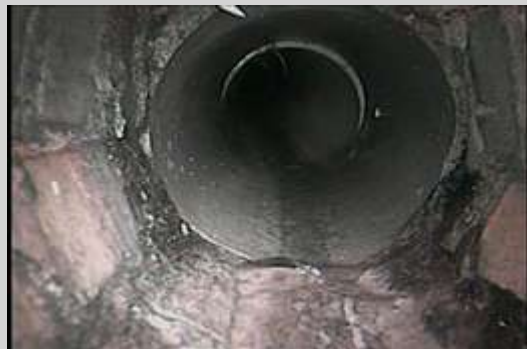
8 in. Circular Unknown Sewer

Offset joint.

Infiltration: **Evidence**
